Single Survey

Property address	254 Leyland Road, BATHGATE, West Lothian, EH48 2TS
-------------------------	---

Prepared by	Allied Surveyors Scotland
--------------------	---------------------------

Date of inspection	23rd March 2022
---------------------------	-----------------

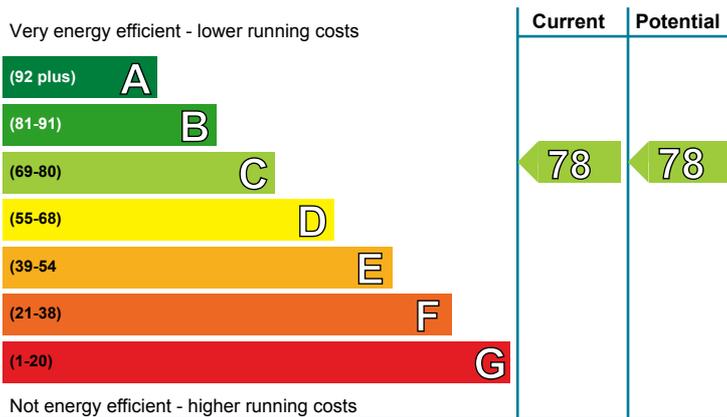
Energy Efficiency Rating

This graph shows the current efficiency of your home, taking into account both energy efficiency and fuel costs. The higher this rating, the lower your fuel bills are likely to be.

Your current rating is **band C (78)**. The average rating for EPCs in Scotland is **band D (61)**.

The potential rating shows the effect of undertaking all of the improvement measures listed within your recommendations report.

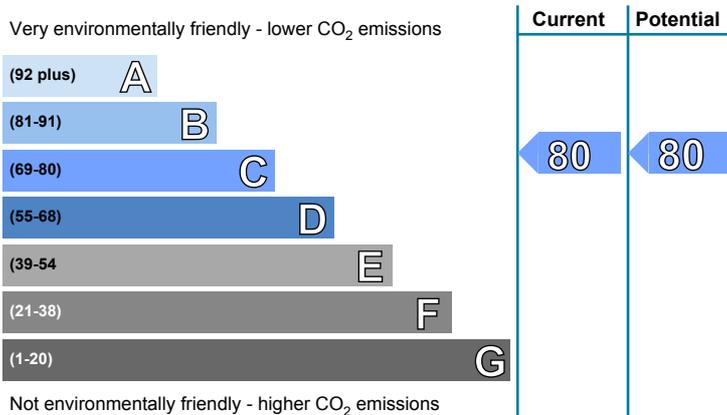
Environmental Impact (CO₂) Rating

This graph shows the effect of your home on the environment in terms of carbon dioxide (CO₂) emissions. The higher the rating, the less impact it has on the environment.
